The Distribution of Las Vegas Wash Water in Las Vegas Bay Following a Storm Event

Todd Tietjen, Ph.D.

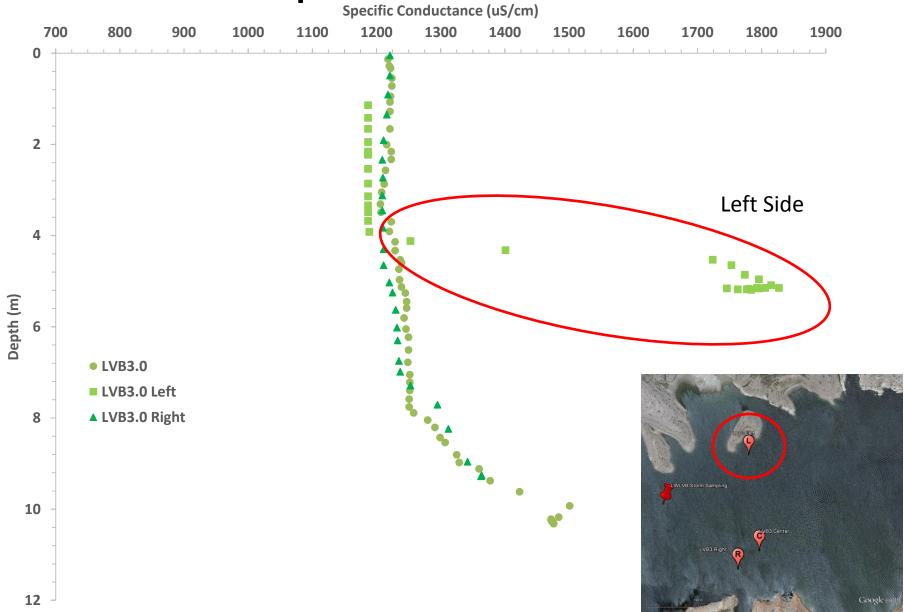
- How did the water travel across the width of Las Vegas Bay?
 - It moved from left to right
 - Was more "common" along Northern Shoreline
 - It did not follow the old river channel
 - It moved in ways that might not be predicted by surface features

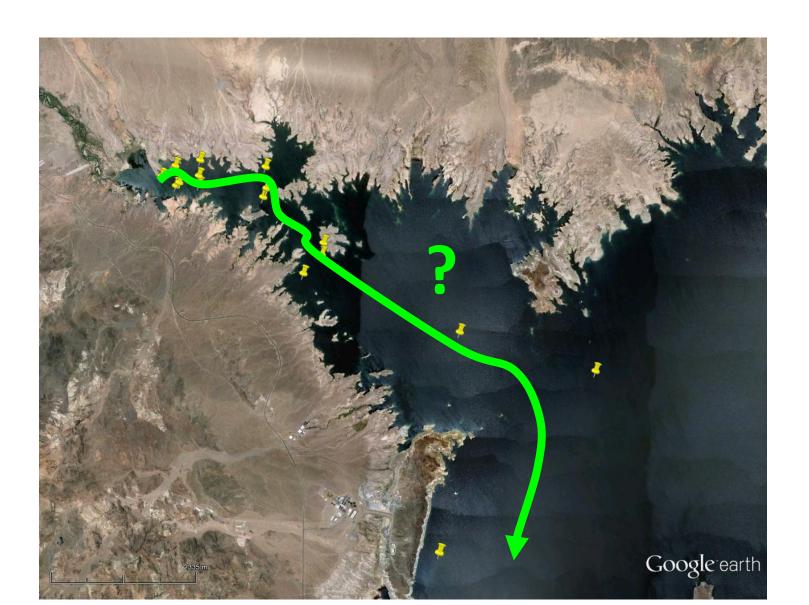
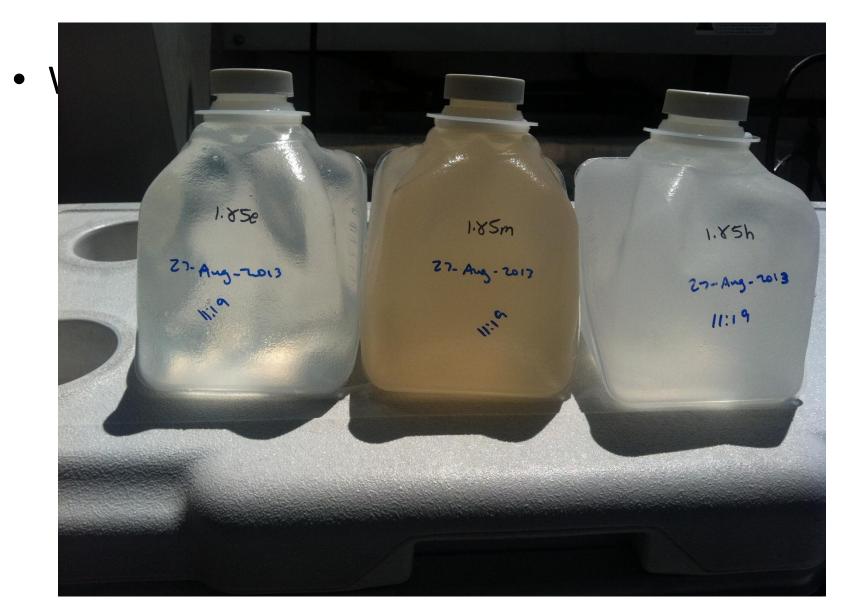
Where did the Water Travel?

- Generally followed the flow patterns determined by specific conductance
 - Underflow and Interflow
- ~3 days after the storm there was still a significant signature
- There was significant turbidity below the interflow as particles continued to settle
- A very small turbidity signature could be seen at the Intake location
